What are we looking at?
The western corner of the castle

What do we know?
Abandonment and ruin of the castle

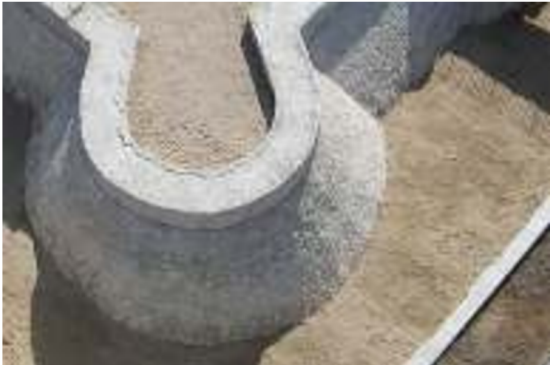
Walls for El Capricho, with the flint pieces visible

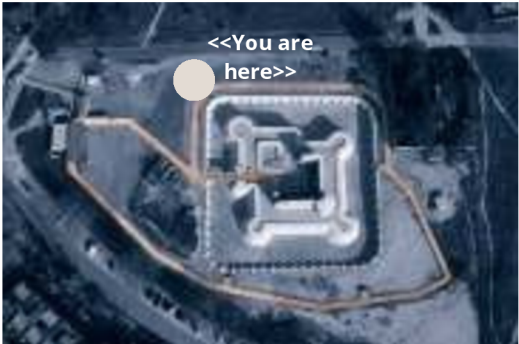
The original bridge

There was a bridge over the moat, and its supports have been preserved in their final form after the 16th-century renovation.

Typically, the original bridge had a solid section and a wooden section; the latter could be quickly destroyed in the event of an attack to isolate the castle.

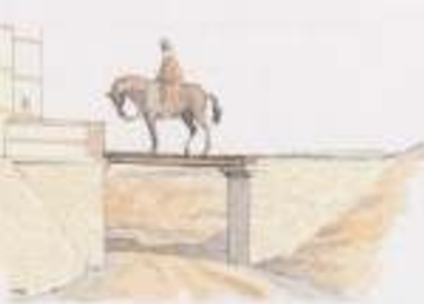
The bridge after the renovation

With the enlargement of the moat, the bridge had to be modified. Defensive measures were no longer necessary, so it was rebuilt with the addition of an arch, some remains of which have survived at the bottom of the moat.
